**MONITORING COMPLETED COASTAL PROJECTS PROGRAM**

MISCELLANEOUS PAPER CERC-91-5

**SPUD POINT MARINA BREAKWATER, BODEGA BAY  
SONOMA COUNTY, CALIFORNIA**

Final Report

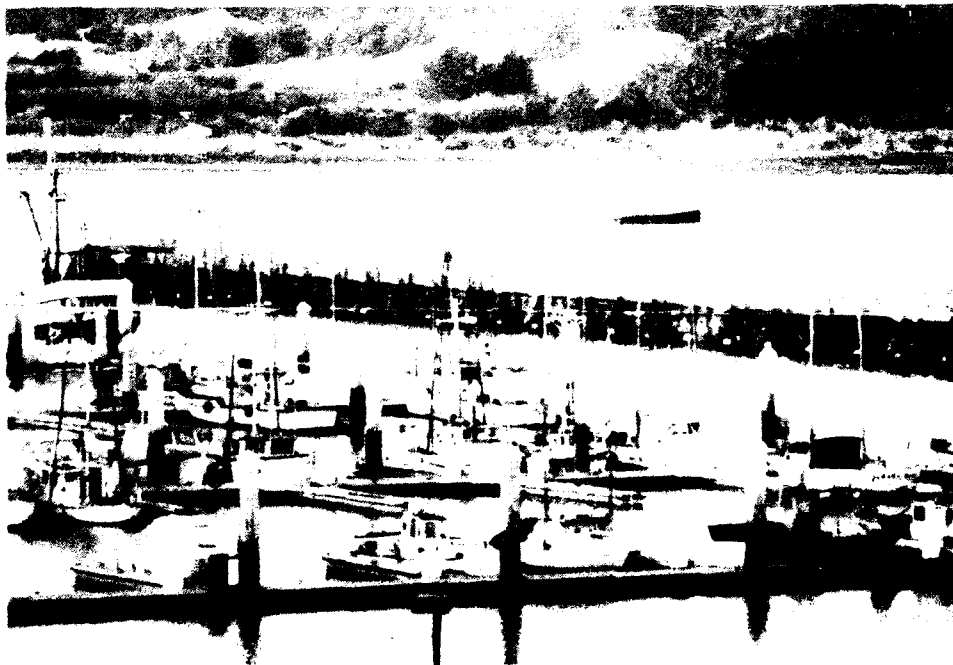
Figure 4. Breakwater at low tide

a. Bend point and fishing platform

b. Seaward leg of breakwater with floating marina docks in foreground

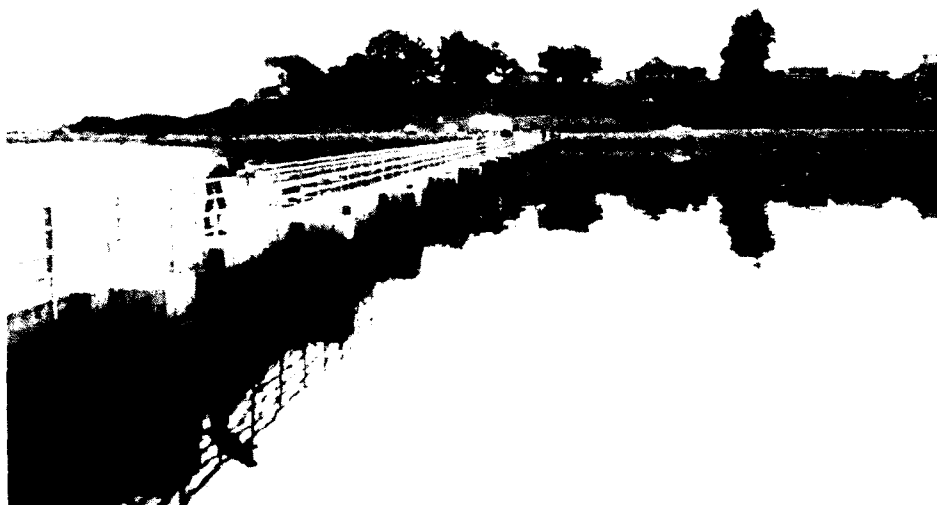
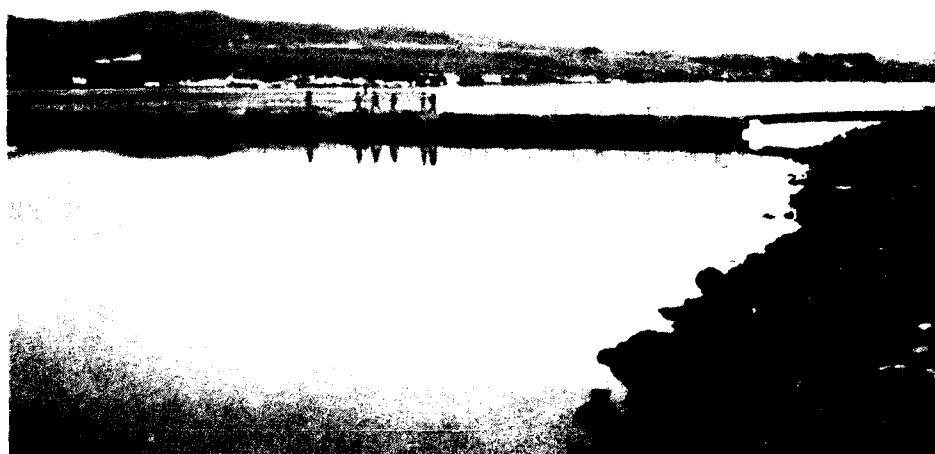
Figure 5 Shoreward leg of breakwater

a. View from fishing platform towards walkway

b. View from shore inside marina
